# PICTURE WALL COMES ALIVE

## CONSERVATION OF LAHORE FORT PICTURE WALL

TEXT | WAJAHAT ALI & ZEINA NASEER BUTT

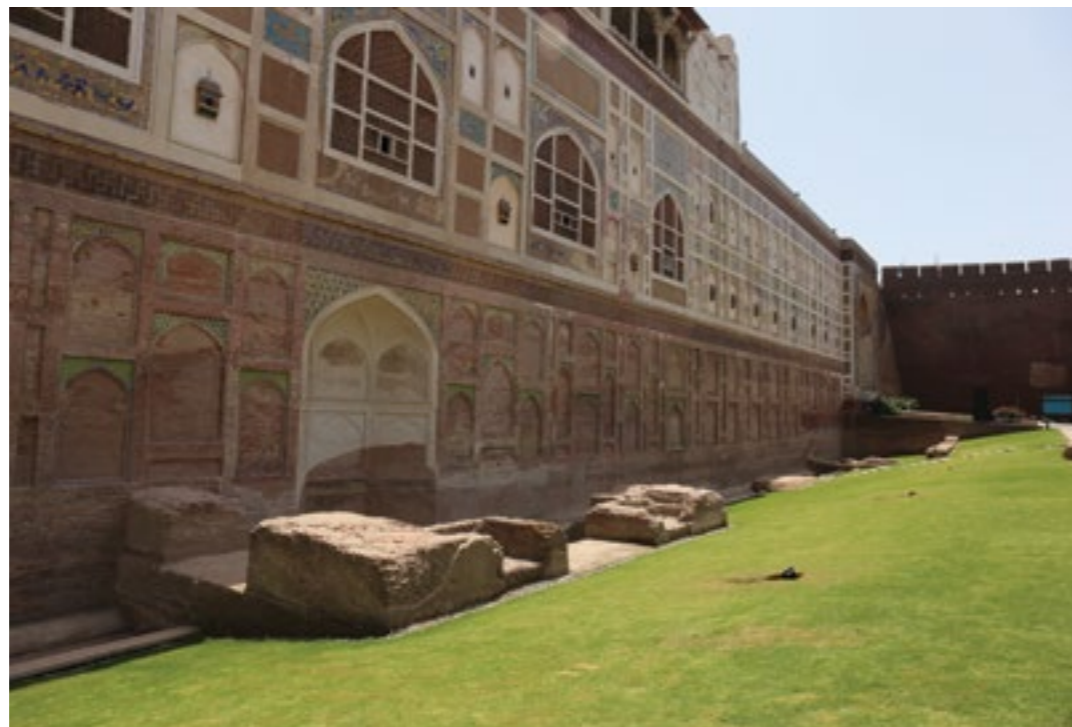
Decorative features of Picture Wall and exposed archaeological ruins (below).

During the documentation process, studies revealed that the original floor level is 2.1 meters below the current ground level. The conclusion of these studies was to remove the latterly added fill to expose the original proportions used in the Mughal era and to reduce the percolation of water which was compromising the structural strength of the wall. New soakage wells were constructed with the purpose of draining out the water that collects in the excavated area below the wall. The excavation work also exposed buried structures from the Sikh and British era. These newly discovered structures are now part of the exhibit made for the visitors.

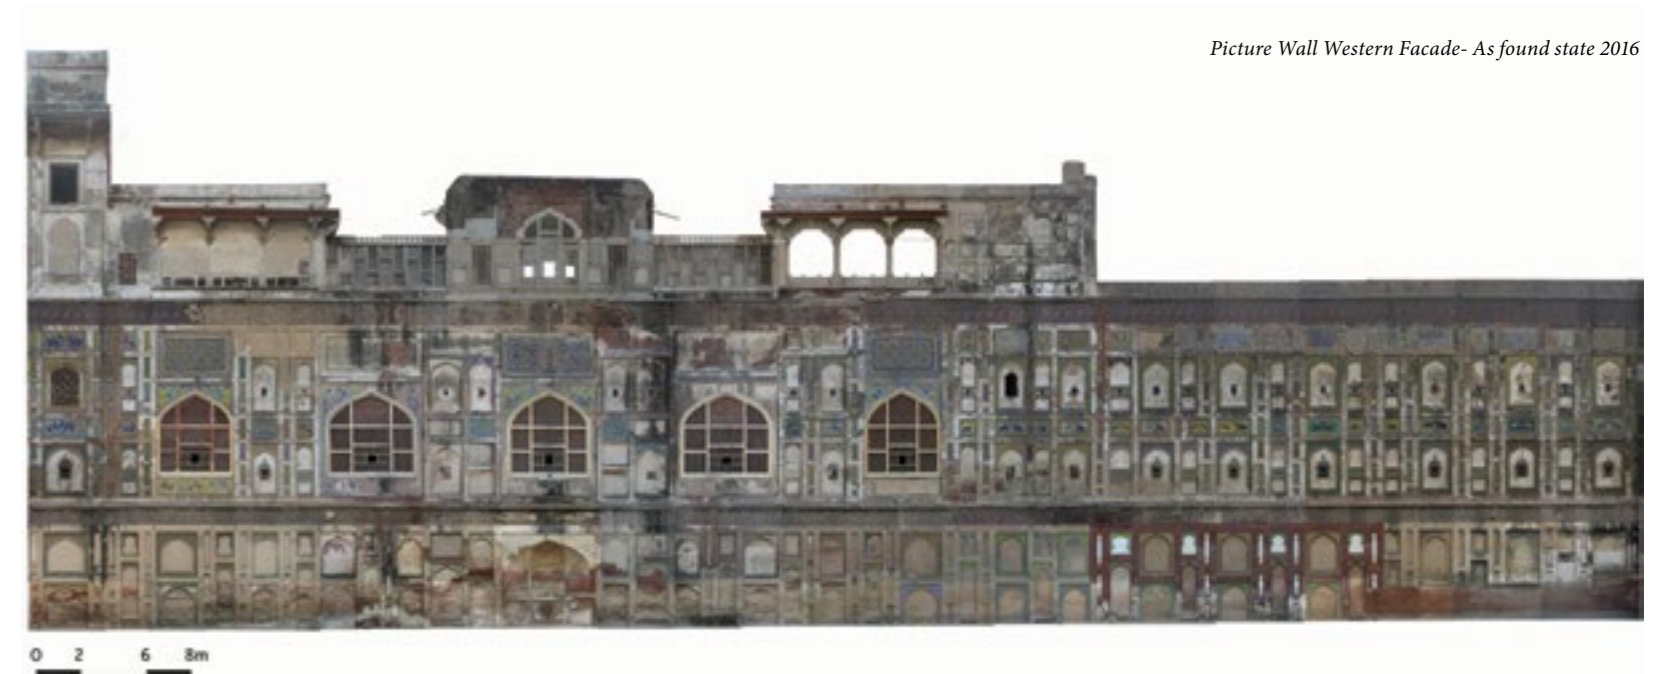
Picture Wall Western Facade- As found state 2016

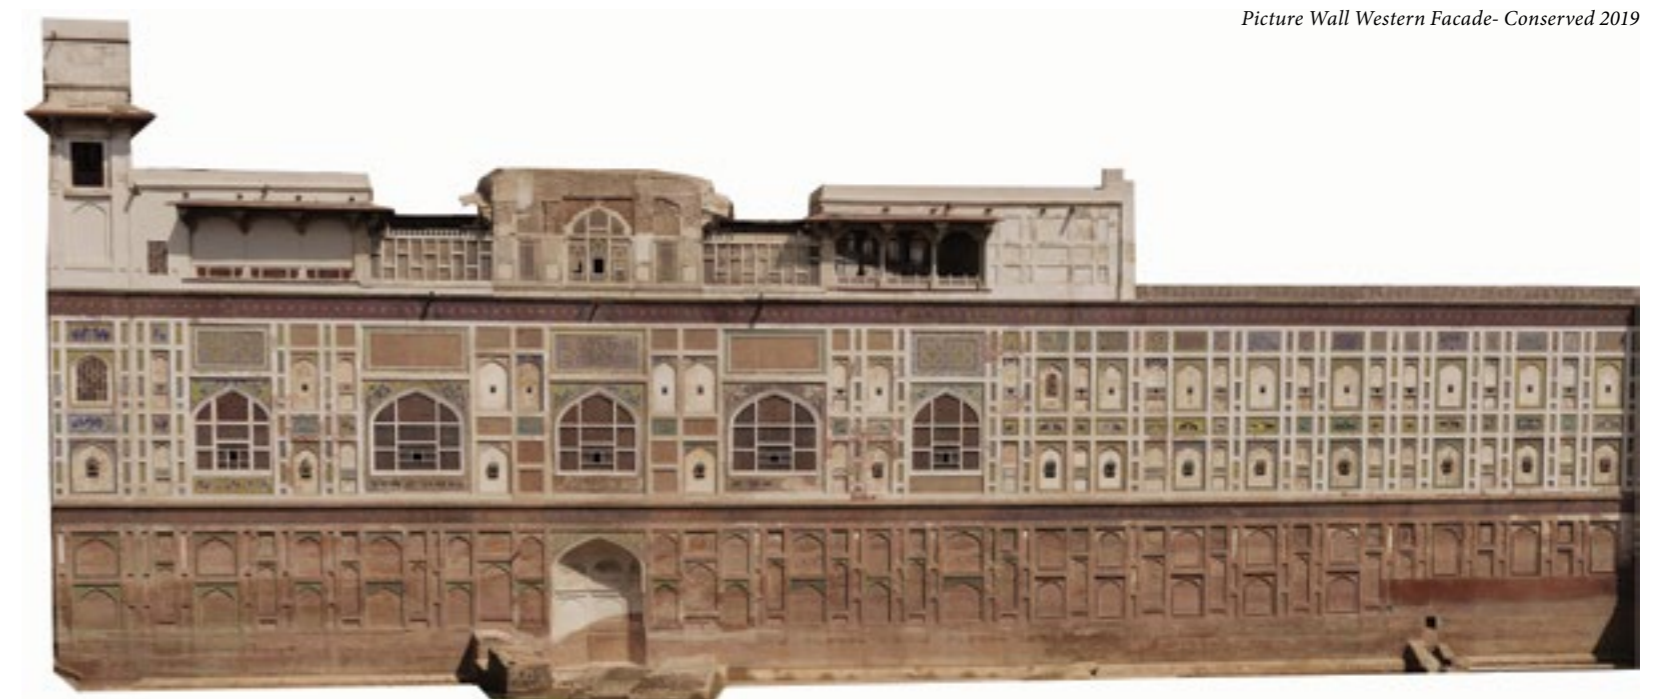
Picture Wall Western Facade- Conserved 2019

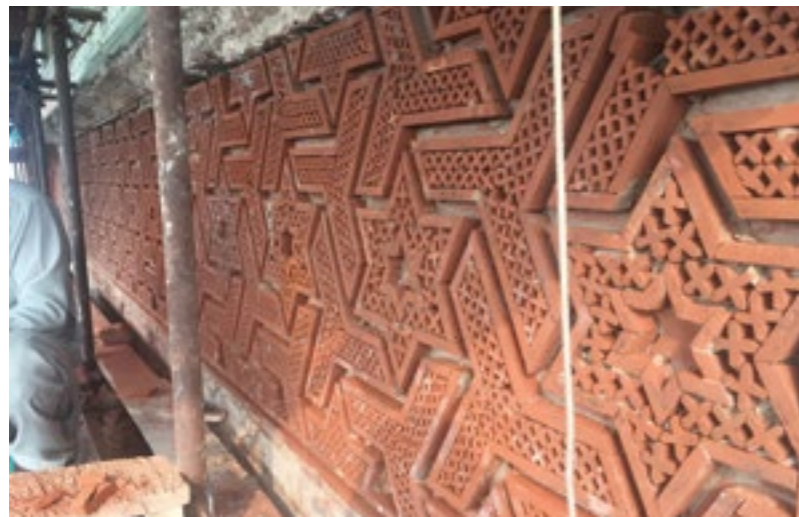
Reconstruction of Filigree Work - Source AKCSP

reconstruction was also done for some parts but only with very particular guidelines such as where there was sufficient evidence particularly for the geometrical patterns such as filigree. The decay of the decorated surfaces is too advanced to justify major reconstruction since evidence was lacking. It was also only considered where the original decoration was totally lost and was implemented only where there was a clear aesthetic benefit.

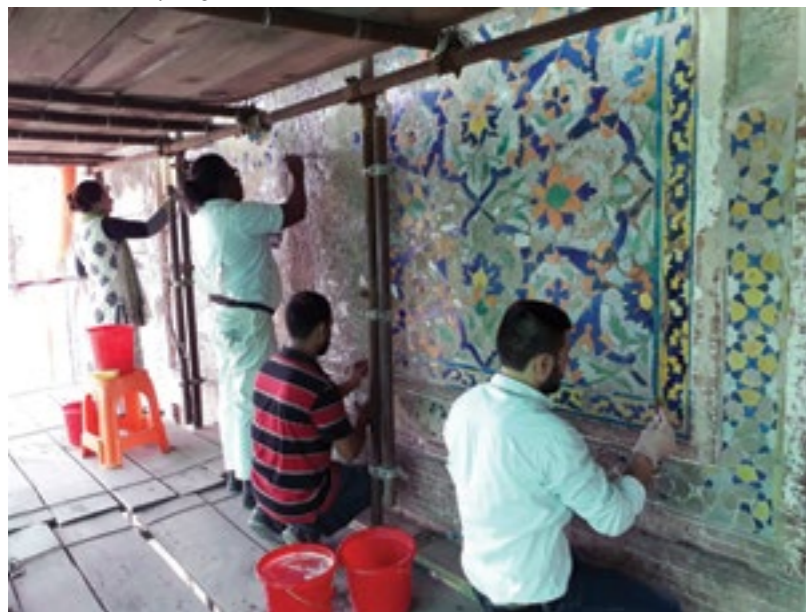
Conservators are consolidating Tile Mosaic Panel in prototype area Picture Wall- Source AKCSP

In the project, the most critical issue to be tackled was the loss of glaze in the tile mosaic work due to its exposure to extreme weather conditions. The glaze was stabilized using a silica binder to increase the binding of the glaze to the tile bodies. Micro-holes in the glazes with weak adhesion were made using hand-drills and the solution was injected into these holes till maximum absorption. The same binder was also applied on the tile mosaic panels to increase the mechanical strength of the tile bodies and to reduce their porosity. Additionally, filling of micro holes with a silica based mortar was also done to seal the surface of the mosaic panels. This mortar was not used on the proto-type because of unsatisfying results. However, continued research allowed for its development and use on the remaining part of the western facade. This methodology of preserving the tile mosaic is an innovative one since there were no previous examples to set a guideline for these treatments.

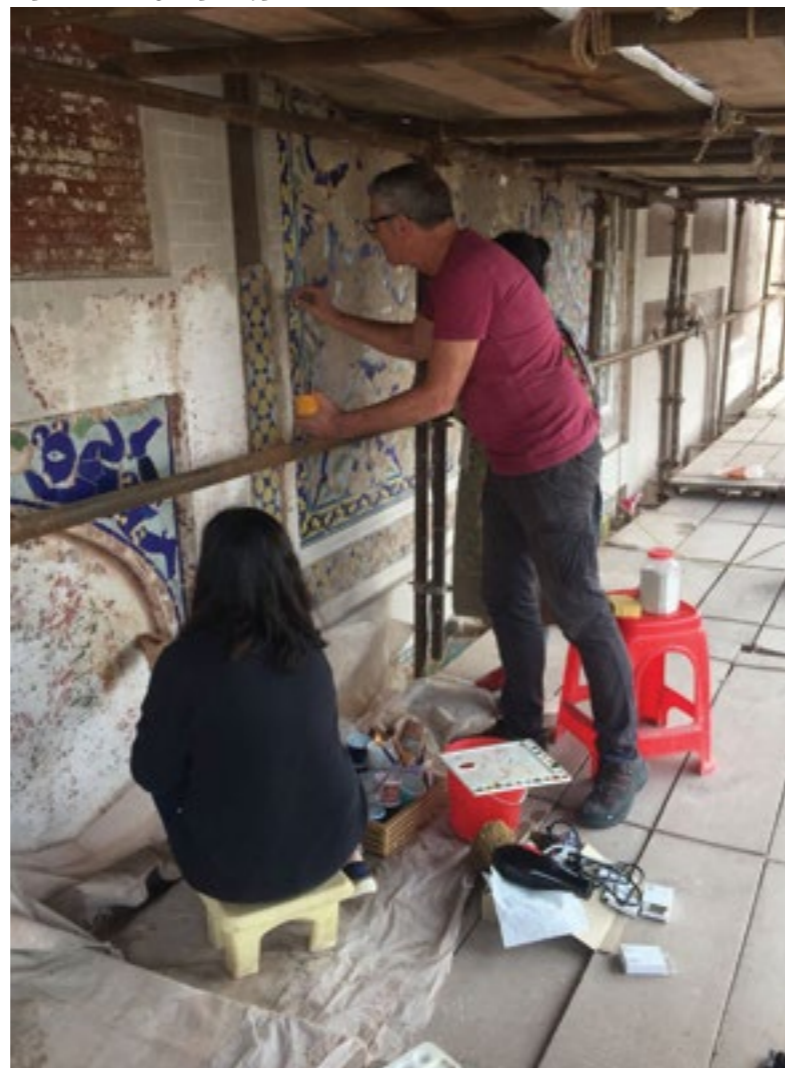
Consolidation of tile mosaic work by international experts - Source AKCSP

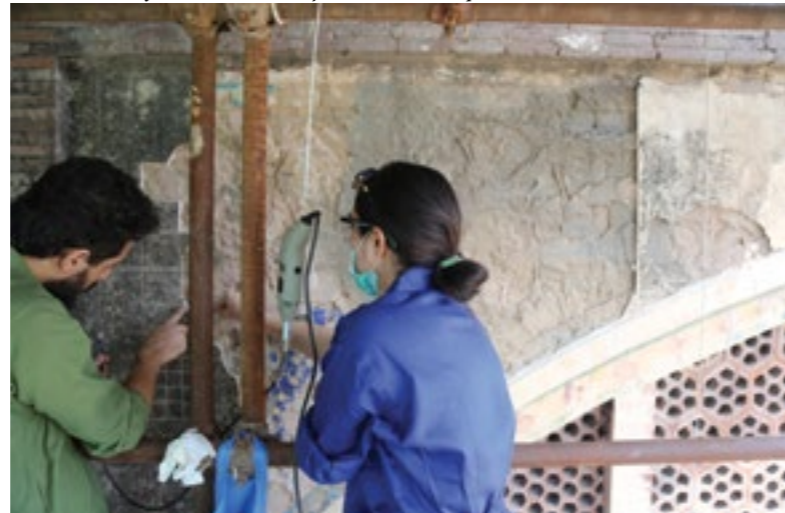
Removal of later layers of plaster from project area - Source AKCSP

many deteriorated areas with plaster. These colonial (British) plaster was analyzed and later it was removed manually from the wall since it was concealing some of the original panels. The wall was also covered with dense bacterial growth which was tested to identify the specific types. The biofilm was removed manually with brushes and a biocide solution.
